**Flood Control Project Maintenance  
Levee Inspections**

**Fall 2016 Levee Maintenance Deficiency Summary Report**

**California Department of Fish and Game Shea Levee**

**Levee Inspection Report By Mile - Fall 2016**

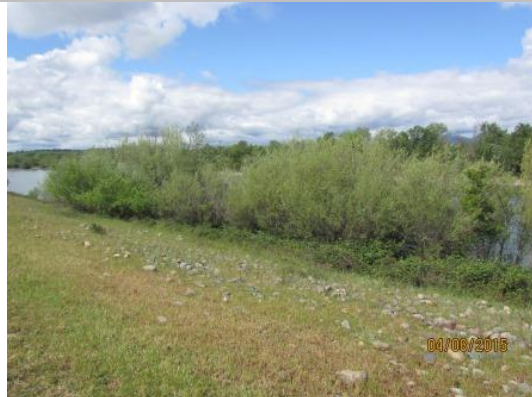
Photo 1 of 2 : FA\_2016\_NA0018\_269\_4\_20160823\_00006.jpg

| T3 : Trim and thin trees to allow visibility of the ground and room to flood fight. | | | | | |

Trim the trees along the waterside slope.

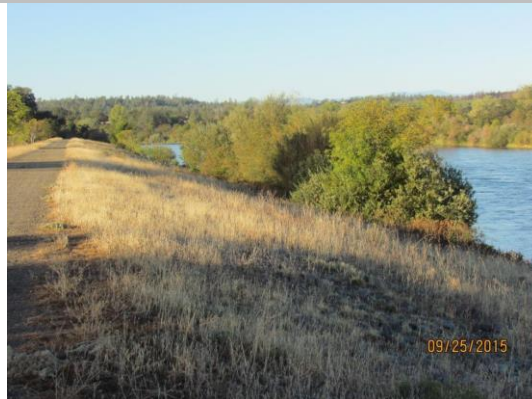
Photo 2 of 2 : FA\_2016\_NA0018\_269\_4\_20160823\_00007.jpg

Trim the trees along the waterside slope.
